July 22, 2015

Re: Damages to Alaska Building from Legislative Information Office Construction

BBFM Engineers, Inc.

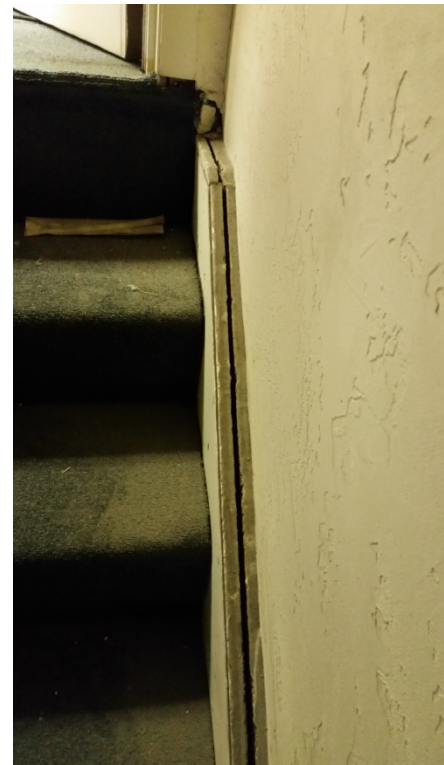
The separation that has occurred between the common wall and the northern part of the Alaska Building is most clearly evident in the northwest stair

Figure 3 Separation at west side of stair

as can be seen in Figures 1, 2 and 3. The large unknown is what this separation means to the structural integrity of this part of the Alaska Building, since the wall provides vertical and lateral support for it. The gaps that now exist raise significant questions as to how stable that support now is. It is not known how much bearing exists on the common wall and how much that was reduced during the construction. During

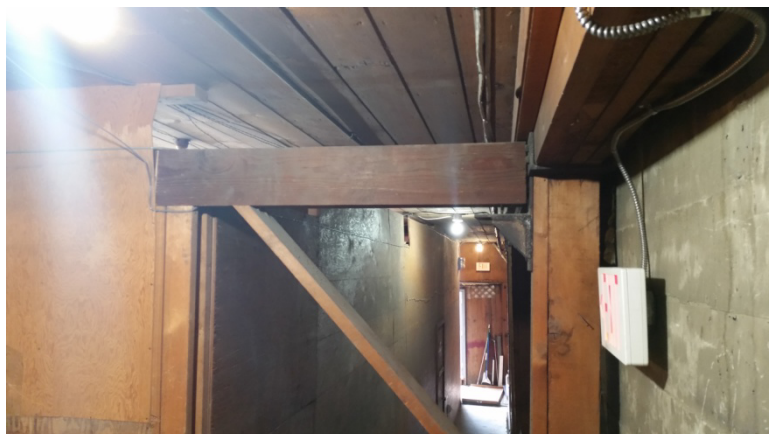
Figure 4 Gap at settled column

Where the basement foundation on the Empress Building and the Legislative Information Office undermined the Alaska Building a large void under the slab led to the sudden settlement of a major building column which was sitting on the slab. It is possible some of the void existed prior to the recent work, but most of the void was created due to the recent work. Although that void was filled with concrete the one column is still lower than it was

before the settlement as is evident in the gaps at the beam supports at the top of the wall. See Figures 4 and 5. This settlement is evident in the slopes of the floors above this column as shown in Figures 6, 7 and 8. There are new cracks evident in the slab in this area. See Figures 9 and 10.

Grout jack slab to level	\$10,000
Raise building structure back to original level	\$15,000
Repair finishes	\$35,000
Future settlement consideration	<u>\$15,000</u>
Subtotal	\$75,000

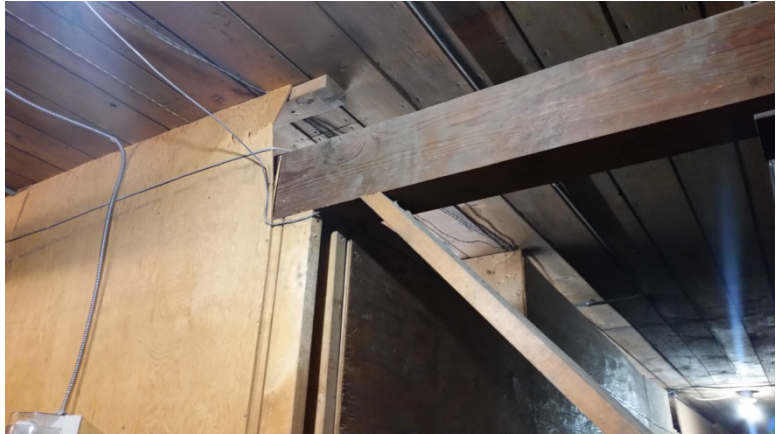
Figure 5 Buckled plywood

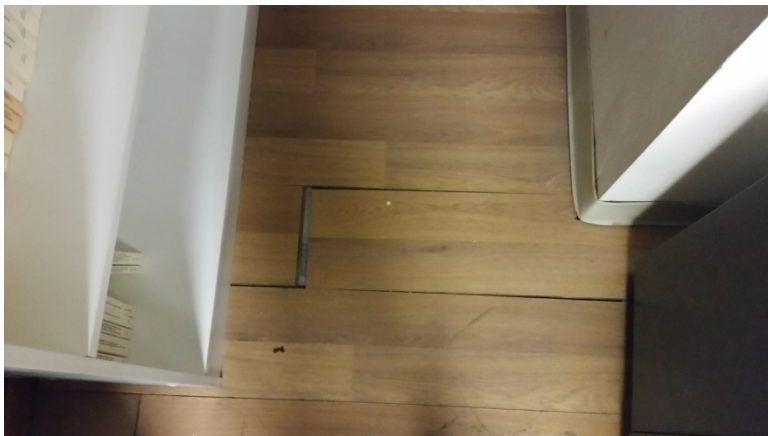
Figure 6 Shifting of floor finishes on slope floor

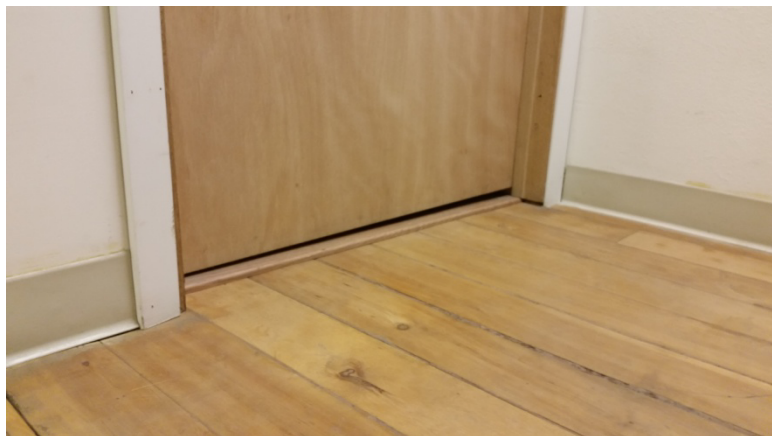
Figure 7 Slope in floor at door sill
