IN THE SUPERIOR COURT FOR THE STATE OF ALASKA
THIRD JUDICIAL DISTRICT, AT ANCHORAGE

**FIRST SUPPLEMENT TO
PLAINTIFF'S INITIAL DISCLOSURES**

Re: Damages to Alaska Building from Legislative Information Office Construction

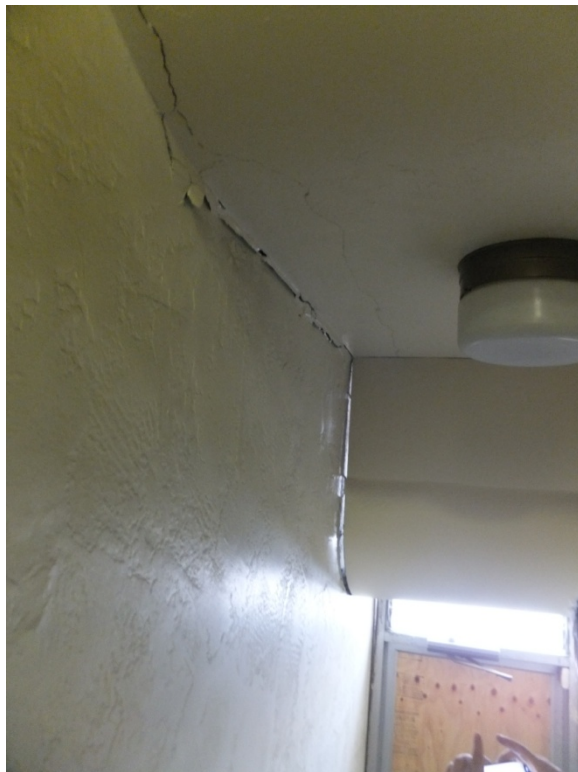
Figure 1 Separation at west wall of stair

The separation that has occurred between the common wall and the northern part of the Alaska Building is most clearly evident in the northwest stair

as can be seen in Figures 1, 2 and 3. The large unknown is what this separation means to the structural integrity of this part of the Alaska Building, since the wall provides vertical and lateral support for it. The gaps that now exist raise significant questions as to how stable that support now is. It is not known how much bearing exists on the common wall and how much that was reduced during the construction. During

Movement of the common wall

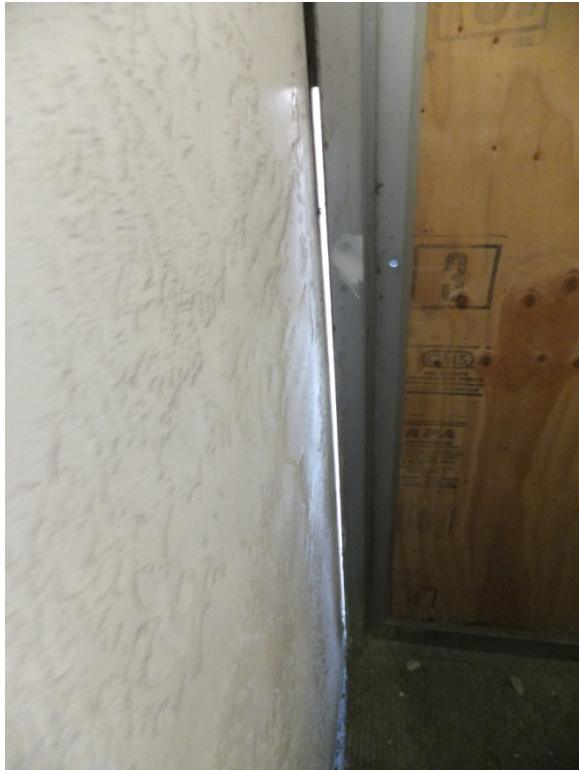
Figure 2 Separation at door frame at base of stair

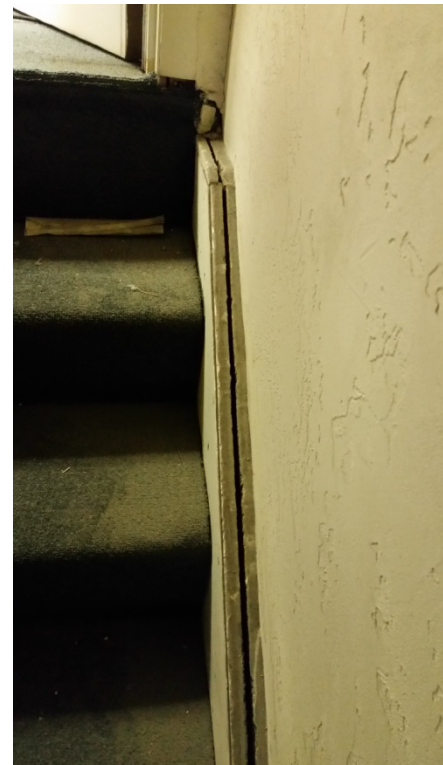
Figure 3 Separation at west side of stair

a seismic event it is possible the bearing could be lost and there could be catastrophic collapse of all or parts of the Alaska Building. At the southern part of the building posts and beams provide the vertical support but the lateral support is still provided by the wall. Again the integrity of the connections to the wall at the south part of the building are unknown.

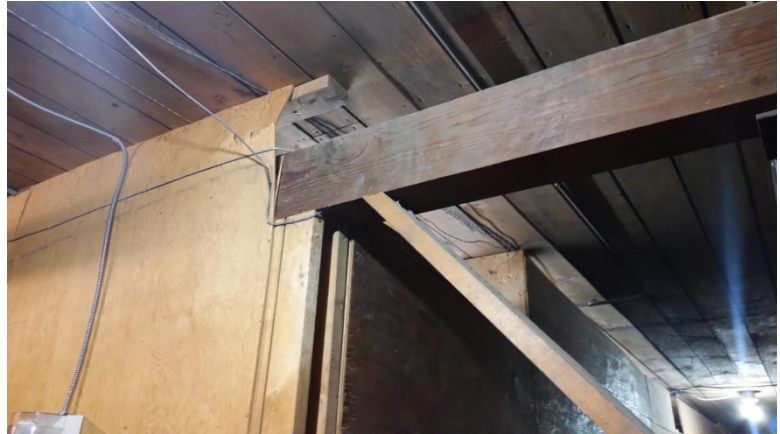
before the settlement as is evident in the gaps at the beam supports at the top of the wall. See Figures 4 and 5. This settlement is evident in the slopes of the floors above this column as shown in Figures 6, 7 and 8. There are new cracks evident in the slab in this area. See Figures 9 and 10.

Figure 5 Buckled plywood

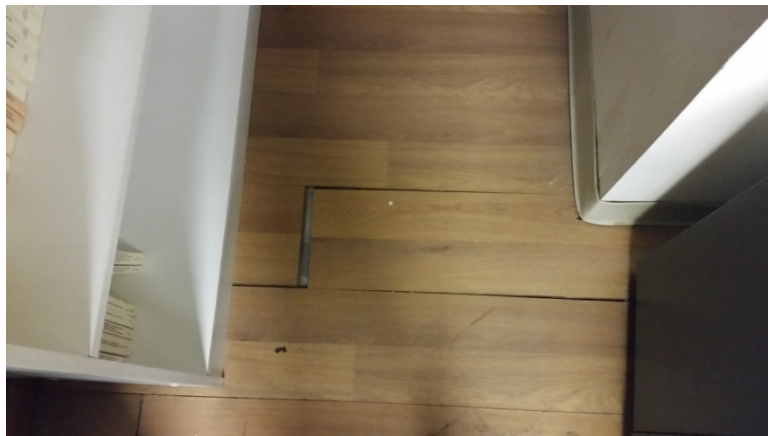
Figure 6 Shifting of floor finishes on slope floor

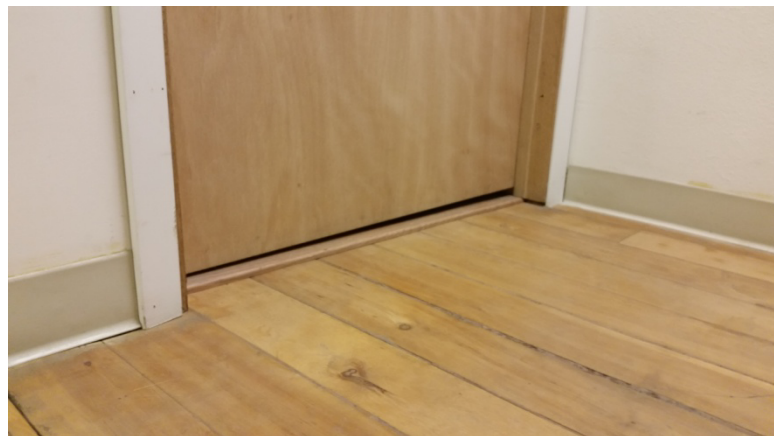
Figure 7 Slope in floor at door sill

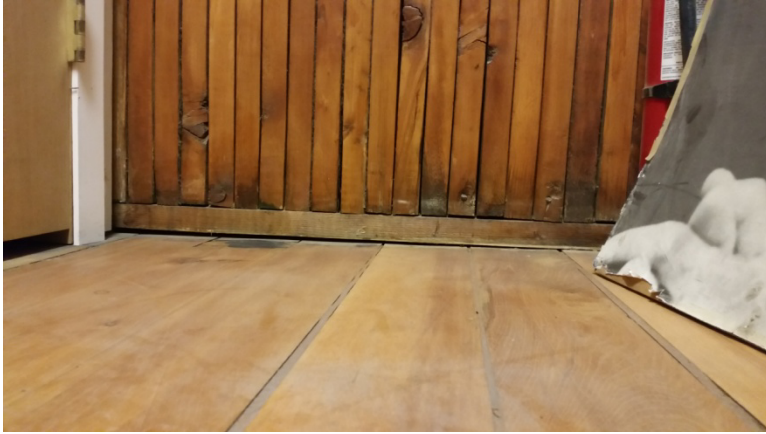
Figure 8 Slope of floor at interior wall

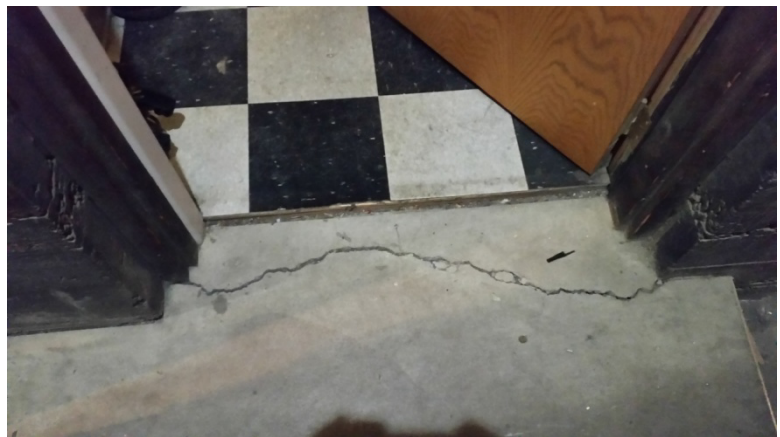
Figure 9 Crack in slab at east side of storeroom.

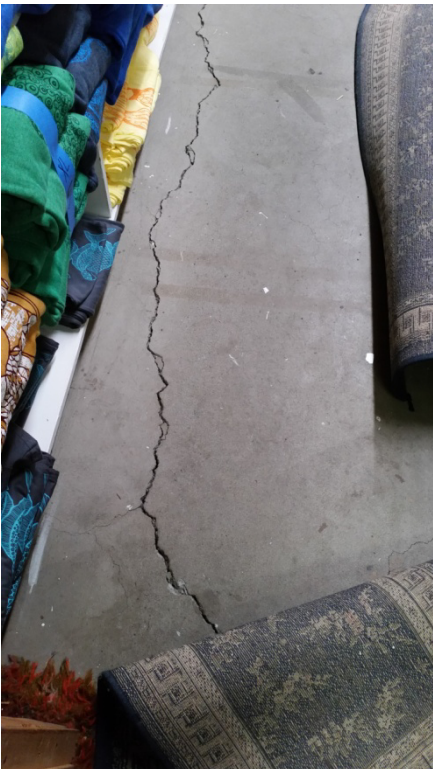
Figure 10 Crack in slab in storeroom

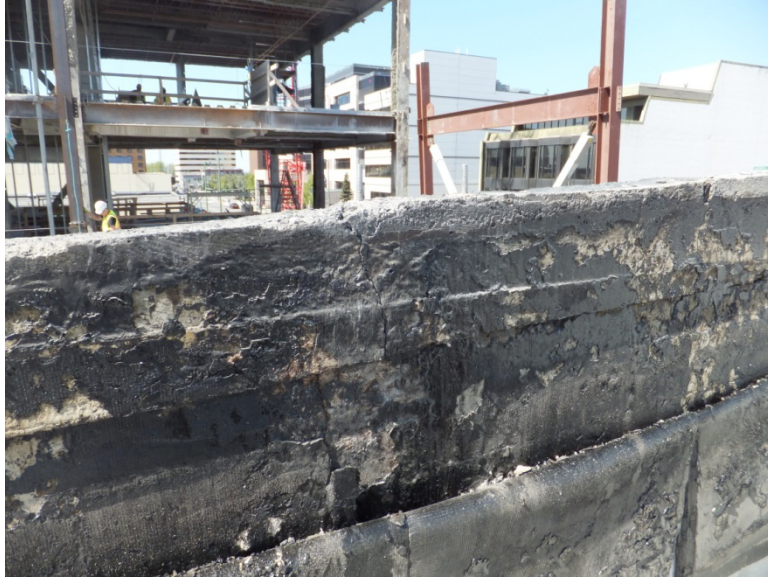
Figure 11 Open top of common wall

During construction the top of the common wall was open to the elements and created a path for moisture to get into the building. See Figures 11 and 12. There were cuts made into the north end roof to determine if there was moisture below the roof membrane, but none was found. There is evidence of water damage in the finishes. See Figure 13. However, the damage to the structure along the common wall could not be fully determined without extensive demolition of the building finishes to expose them.

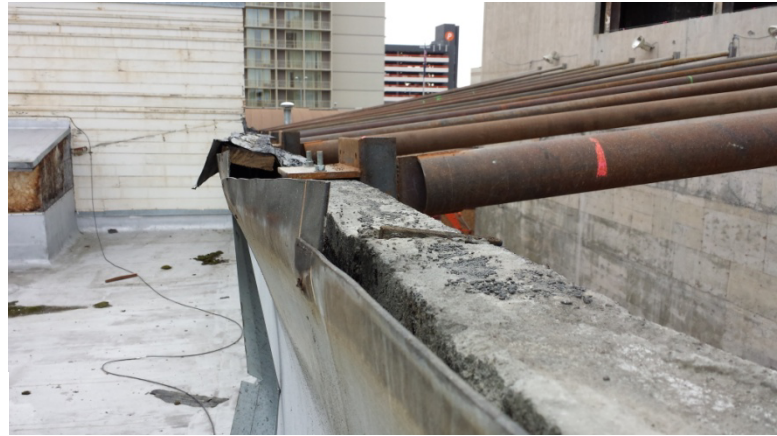
Figure 12 Open top of common wall

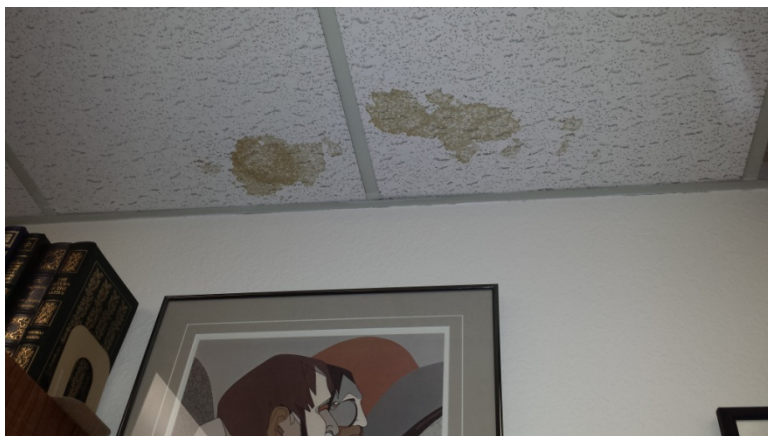
Figure 13 Water damage to second floor ceiling
